Community Fact Sheet – Post Bushfire Vegetation Management on Bendalong Rd, Manyana

6 April 2021

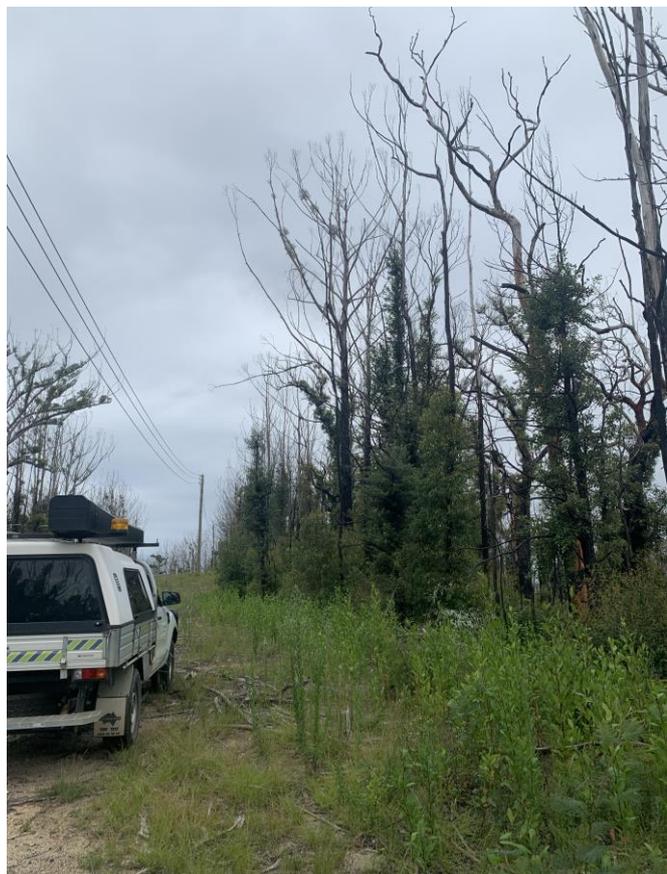
Figure 1: Hazardous trees on Bendalong Rd

Further, epicormic growth (the green fluffy growth seen on badly fire affected trees) also presents a risk, as it is weakly attached to the trunks and can fly off into powerlines, creating further risk of fire. We appreciate that trees with green epicormic growth, which may appear vital from a distance, may not in fact be healthy or structurally sound, and we are guided by expert advice from qualified arborists in this regard.

Typically, "hazard trees" created by the fires are trees that have lost their canopies and demonstrate mostly epicormic growth (fine, lightly attached sprouts on their trunks). Trees with healthy canopies are not generally considered fire-related hazard trees.
